Lake Seminole Restoration: Everything but the Kitchen Sink

Rob Burnes, MAS, MS

This article originally appeared in the Florida LAKEWATCH newsletter, Volume 75 (Dec. 2016)

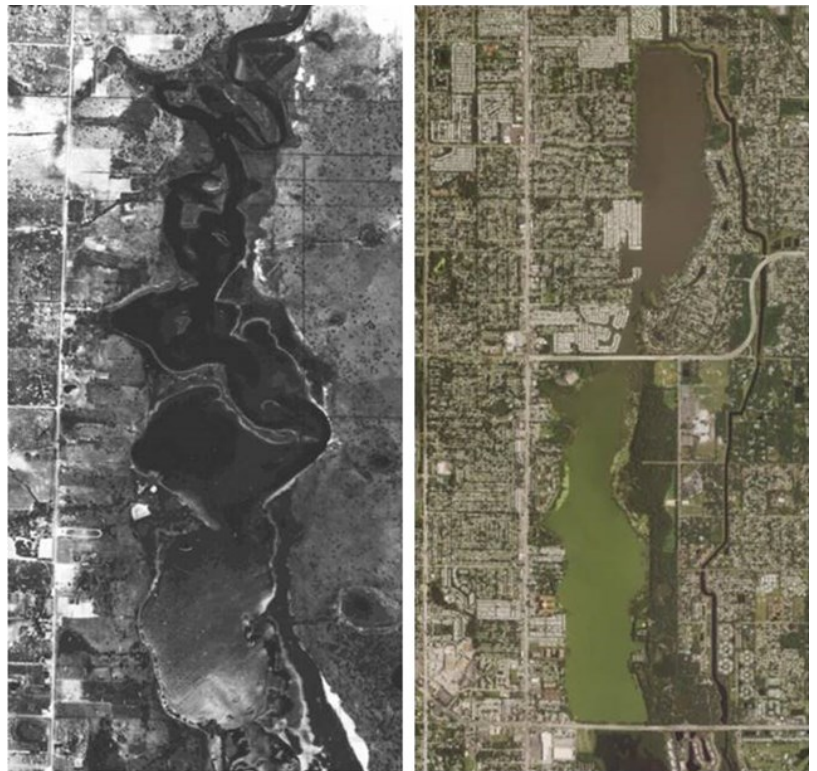
Figure 1. Lake Seminole prior to 1940's (Left) and Lake Seminole Present Day (Right)

Lake Seminole is a 685-acre hyper-eutrophic lake located in the west central portion of Pinellas County on the west coast of Florida, about 90 miles west of Orlando. It was created by impounding an arm of Long Bayou, a brackish water segment of Boca Ciega Bay that ultimately spills into the Gulf of Mexico. The creation of the lake was in conjunction with the planned construction of Park Boulevard by the State Public Roads Administration. There were quite a few reasons for the creation of Lake Seminole with the two major reasons being to provide irrigation of orange groves and as a potential potable water source. A fixed weir on the north end took flow into the lake from Long Creek and water flowed out of the system from a fixed weir on the south end of the lake (Figure 2). In the late 1970s, to alleviate upstream flooding and to reduce the flow of untreated stormwater into the lake, the Seminole Bypass Canal was created. This provided immediate relief from flooding but only minimally addressed the water quality degradation.

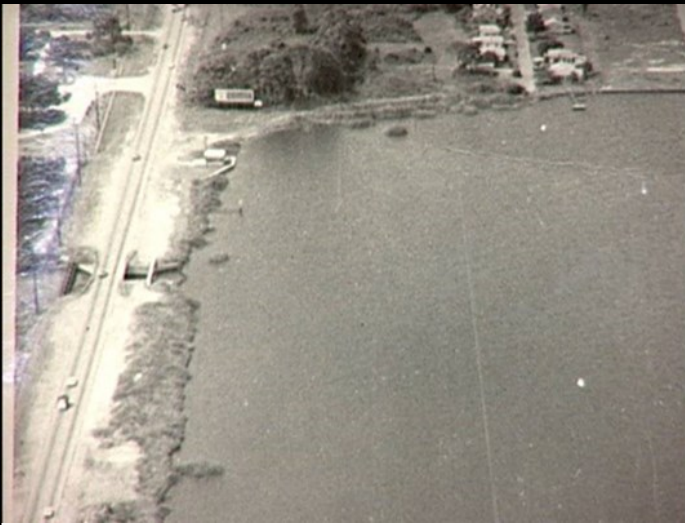
Figure 2. Lake Seminole Outfall during Construction of lake

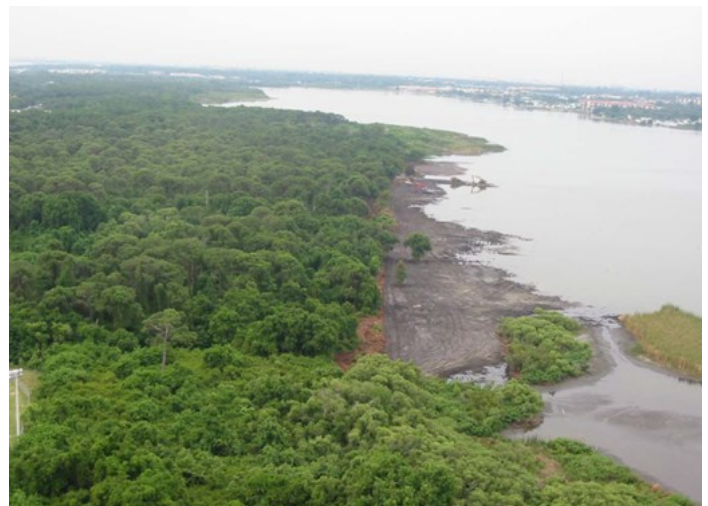
Figure 3. Lake drawdown for shoreline muck removal

To date, several projects listed in the RAP have been completed or are nearing completion. These projects focused on cleaning up the lake shoreline and placing lake-level instrumentation on the lake. The first project completed removed organic sediments from the littoral shelf in 2006 and was a continuation of a smaller-scale project of similar scope conducted by Florida Fish and Wildlife Commission (FWC) in 2002. The work focused on removal of organic sediments from nearshore areas and tussocks. Approximately 130,000 cubic yards of organic sediments were removed, along with over 26 tons of garbage and debris (Figure 3). To visualize how much material was removed, the 130,000 cubic yards of material would create a 20-foot high pile of dirt over an entire football field, and the garbage and debris removed weighed as much as three elephants.

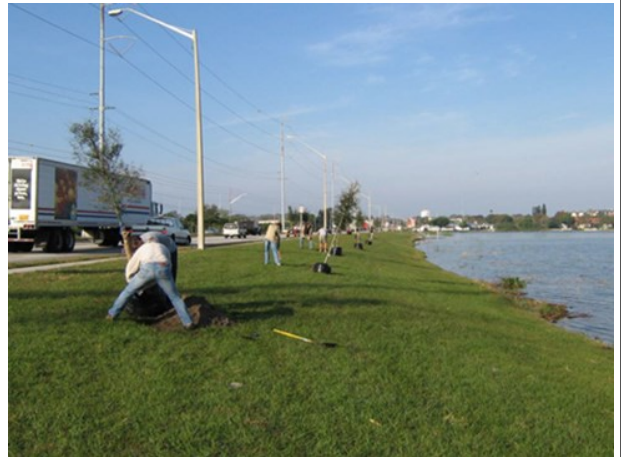
Figure 4. Upland revegetation after exotics removal

The next project to be undertaken was the restoration of priority wetland and upland habitats. The goal was to improve near-shore upland habitats through vegetation control. The main portions of this project were completed in 2008, though continued maintenance is still occurring on an as-needed basis. There were many areas targeted for restoration ranging from small strips of land adjacent to roadways that comprised no more than a few thousand linear feet to a large tract of wetland and upland several acres in size. The main upland species targeted were Brazilian Pepper (*Schinus terebinthifolius*) and air potato (*Dioscorea bulbifera*) and the main near-shore targeted species were cattail and willows (*Salix* sp.). The areas where nuisance vegetation was removed were immediately revegetated with native plants (Figure 4). These three projects helped to tackle the lake's issues but there was still much more work to do.

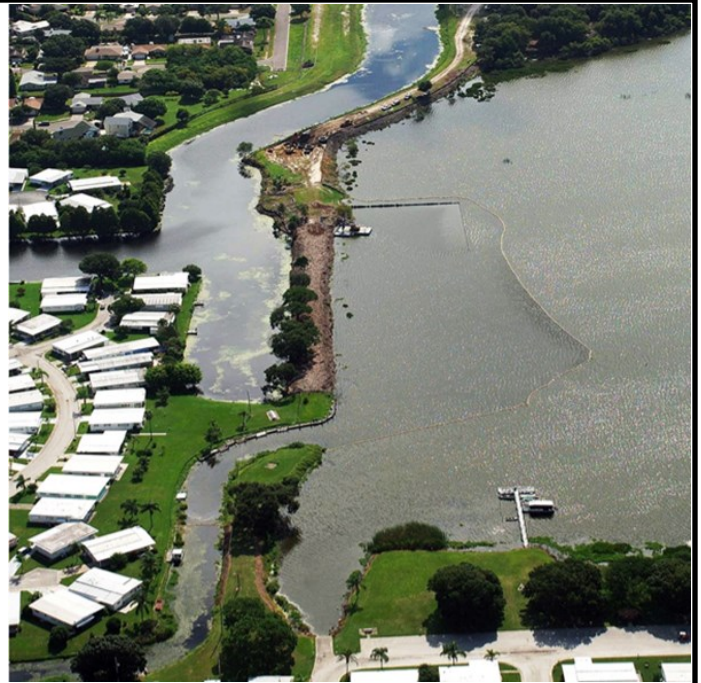
Figure 5. Alum facility on Lake Seminole during construction

The overall goal of the Stormwater Retrofit project is to reduce nutrient loads prior to entering the lake by injecting Alum (aluminum sulfate) into the stormwater which helps to sequester nutrients and sediments prior to entering the lake. Alum has long been used as a phosphorus removal tool in the wastewater treatment world and over the last 30 years it has gained acceptance as a tool to help remove nutrients and suspended sediments in surface water systems (lakes, streams, ponds, etc.). The process for treating the stormwater is relatively

simple. The systems were designed to release the Alum to only treat stormwater flow after it reaches a minimum assigned level for a certain period of time, thus ensuring the flow is storm-event driven. The rate of Alum release is based on flow, so as flow increases more Alum is released to adequately treat the stormwater. Based on preliminary testing, it is anticipated that removal rates will be upwards of 80% of the total phosphorus and total suspended solids in the stormwater. This reduction in nutrients and sediments will have a great impact on the health of the lake by reducing the annual nutrient load to the lake. This project will be completed and all of the systems will be operational by spring of 2017.
